June 29, 2018
File: PVT 1860P 907 N. Pope St. Structure Assessment

Reference: 907 N. Pope St. Structure Assessment

In accordance with your request, Stantec CSI has performed a visual assessment of the commercial structures located at 907 N. Pope St. in Silver City, New Mexico. The report of our investigation is presented herein.

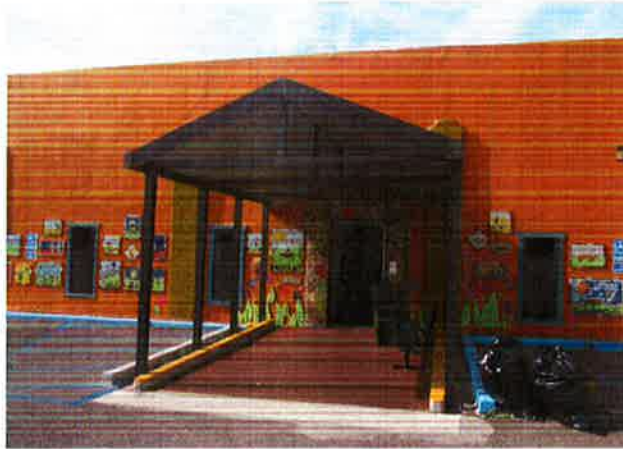
- The construction of the main building appeared to be perimeter concrete block walls upon a concrete slab-on-grade foundation.
- There were 7 windows located on the north wall. There was a hairline diagonal crack located on the lower east corner of the west-most window framed opening. There was a door located on the mid-section of the north wall. No cracks on the door framed opening were noticed at time of the inspection.

Photo 1
Main building elevation looking south.

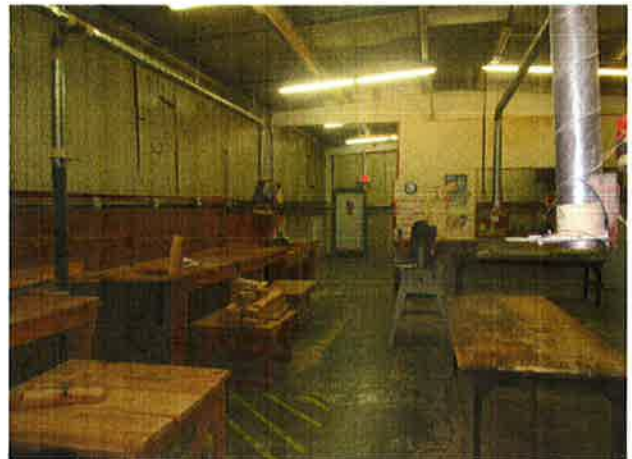
- The metal addition was used as a wood shop. There were several hairline cracks on the exposed concrete floor of the metal addition.
- The metal addition was in good condition.

Photo 2
Metal addition looking north.

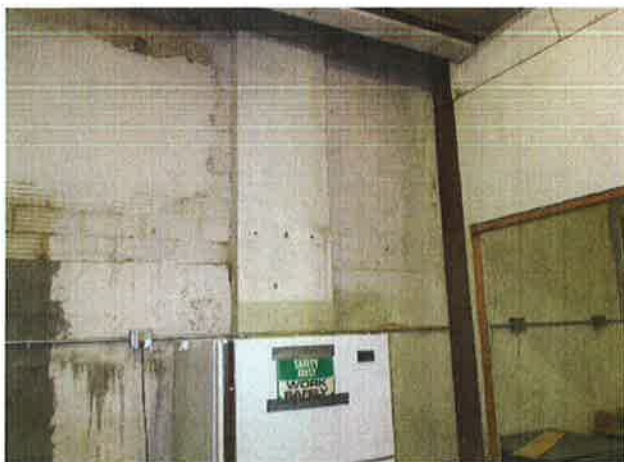
Photo 3
West wall of the main building.

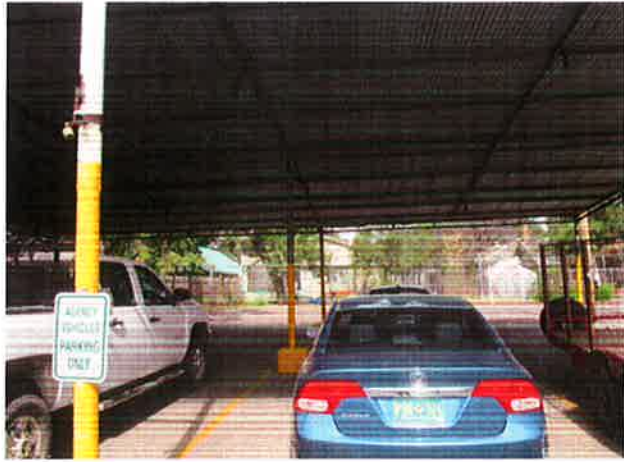
- Overall, the main members of the metal building show moderate rusting.

Photo 4
North section of metal building.

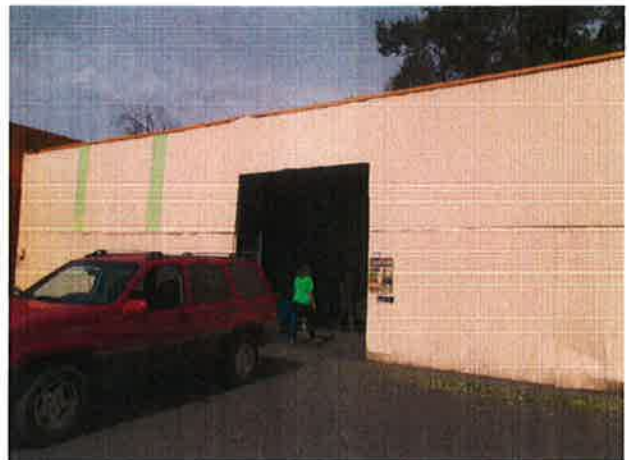
Photo 5
South section of metal building.

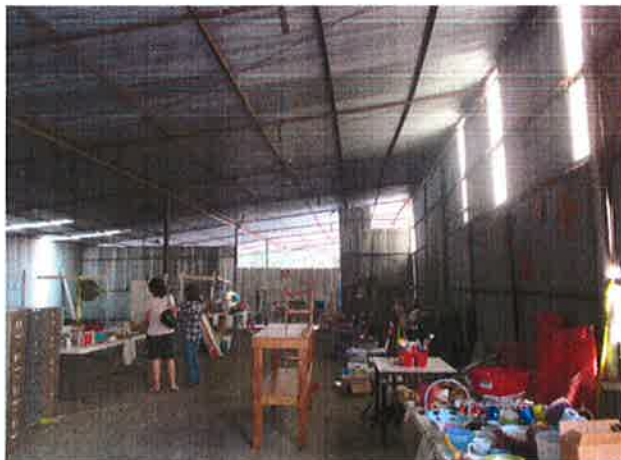
Photo 6
South section of metal building looking north.

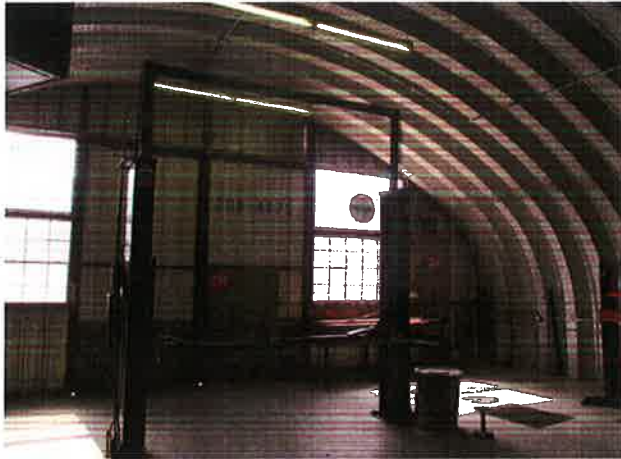
- The mechanical shop was located on the north side of the commercial property.
- The mechanical shop was constructed as a metal Quonset hut upon a concrete slab foundation.
- The mechanical shop was approximately 40 feet wide by 60 feet long.
- The concrete floor of the mechanical shop was exposed. There were several closed diagonal cracks on the concrete floor.
- There was what appeared to be a 5 feet wide by 15 feet long repair pit located on the west side of the mechanical shop. The repair pit was covered with concrete. There were diagonal cracks located at all four corners of the repair pit.
- There was a garage door and a panel door located on the west wall of the mechanical shop. There were two windows and a garage door located on the east wall of the mechanical shop.

Photo 7
Mechanical shop looking east.

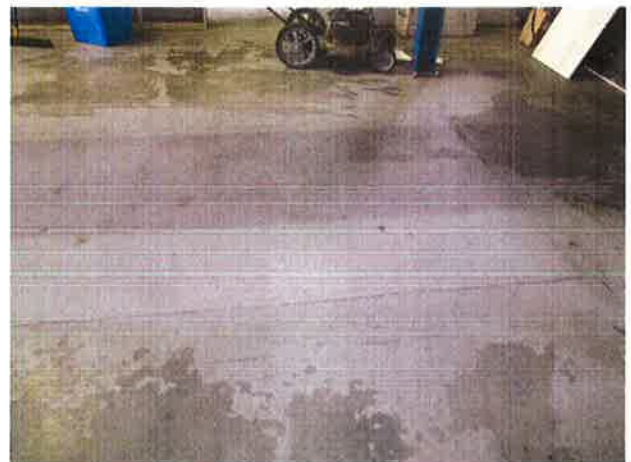
Photo 8
Covered repair pit located on
the west side of the
mechanical shop.
